# Manhole Inspection Summary

Manhole # S31QQ\_012MH

Insp Date: **5/11/07 9:22 AM**

**Location** Address: **2434 25TH ST**

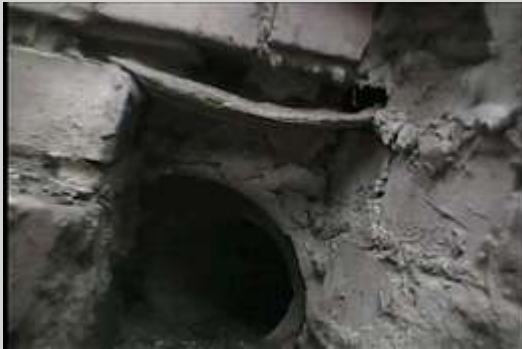
### 6 in. Circular Gravity Sewer Pipe Out @ 12 O'Clock

Rod and Bar (Angled)

Infiltration: **None** Pipe Seal Cond: **Unknown**

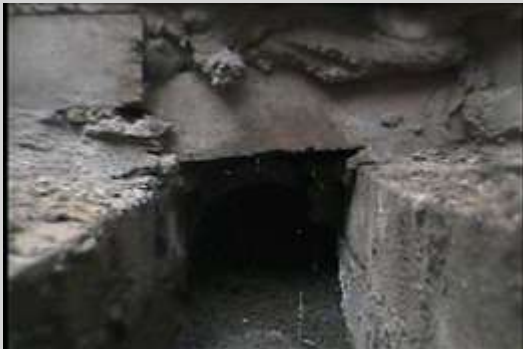
6 in. Circular Gravity Sewer  
Pipe In @ 7 O'Clock

Rod and Bar (Angled)

Infiltration: **None** Pipe Seal Cond: **Unknown**
